LUMICHRON Clock Restoration

Clock Restoration Examples – References

LONGWOOD UNIVERSITY, Lancaster Hall, Farmville, Virginia

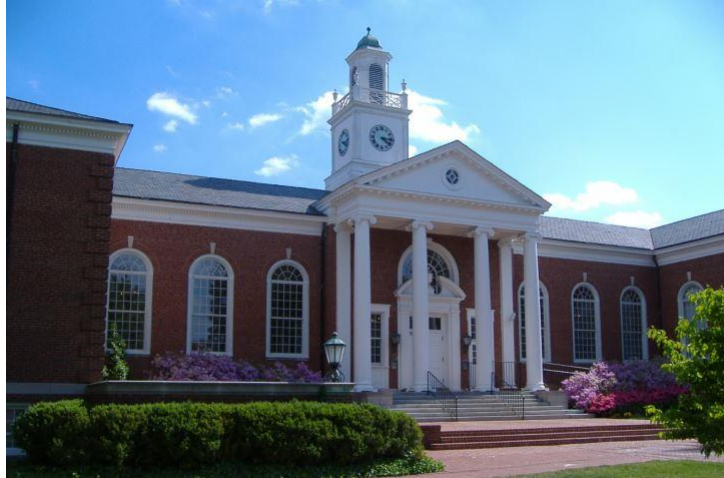
New clockworks, restored original cast-iron dial

LUMICHRON was awarded the contract for the replacement/refurbishment of the four 54" diameter historic clocks at Longwood University in Virginia. This is a viable option when original mechanical clockworks need to be replaced, and the display clock is in good condition. In this case, the Seth Thomas 5-foot diameter Roman clock dials, made of cast iron with glass panes, just needed re-finishing, with new glass to replace broken or cracked panes.

Work began with a site visit. Then LUMICHRON staff removed the original cast-iron, glass-paned clock dials and brought them back to our shop in Michigan for sand-blasting, re-finishing, and cutting all new ¼" thick tempered glass panes, with a white translucent finish. We also fabricated new clock hands, and replaced the mechanical clockworks with "up-to-the-minute" slave clock movements and an automatic master clock controller with GPS synchronization for exact time keeping and bell striking functions

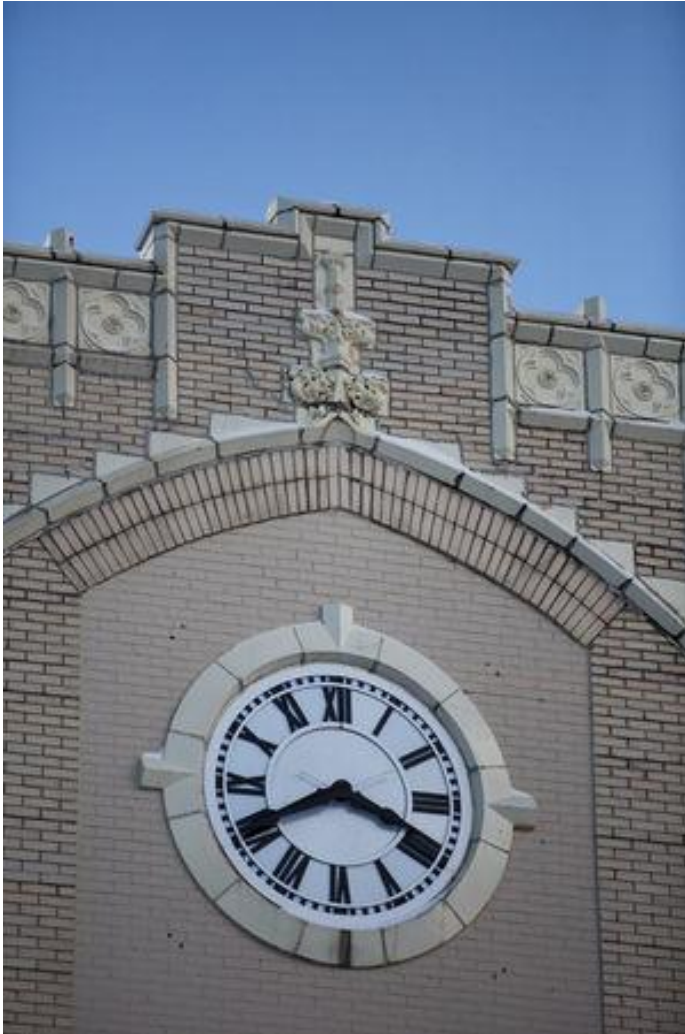
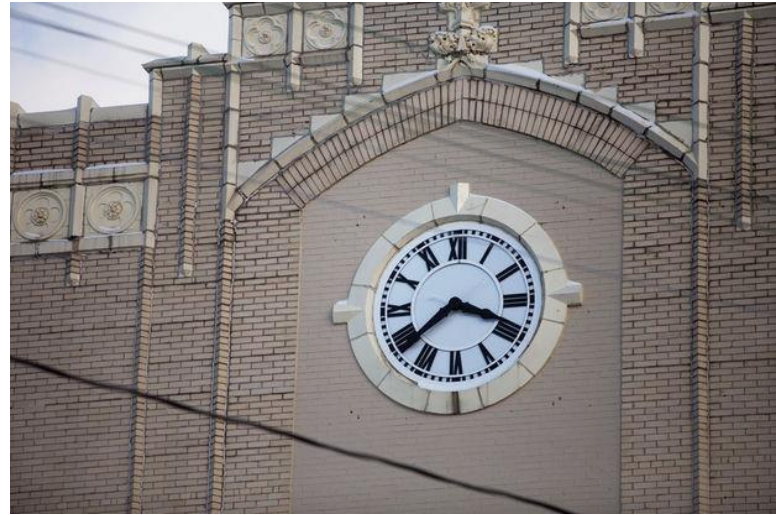
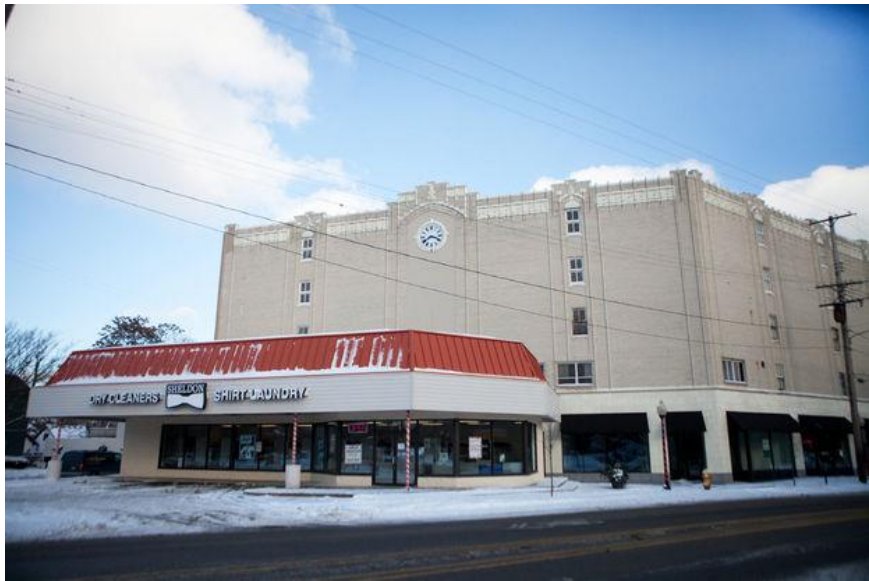
Restored Seth Thomas clock returns to Eastown's landmark Kingsley Building

The antique Seth Thomas clock hands atop the landmark Kingsley Building are turning again, greeting drivers approaching Eastown on Lake Drive SE as they once did.

For years, the clock face and frame were frozen in stasis behind a square, modern clock with a Kent Records Management logo on the front of the building.

Originally built in 1926, the clock was restored this summer by Grand Rapids clockmaker Ian Macartney's company **Lumichron**, and was installed last week on the top floor of the five-story building.

The clock's original inner-workings, brass gears, pendulum and wooden arms were **donated** to Bazzani in 2011 by Alan Teelander of Lowell, who saved them in his garage after Zondervan Publishing Co. moved from the building in 1974. The restored clock reuses the original cast-iron frame, but the original machinery could not be re-integrated into the clock, said Hawkins.

Instead, the clock has been automated with modern controls that are tied to a master clock in the building that "does everything but make hot chocolate." Back-lighting and seasonal time changes are all handled automatically. The clock face is backlit from dusk to dawn each day.

The restoration by Macartney took four months. Hawkins said the white translucent glass on the clock face was extremely difficult to locate in large and thick enough quantity, but Macartney found an art glass foundry in Pennsylvania which had some residual stock.

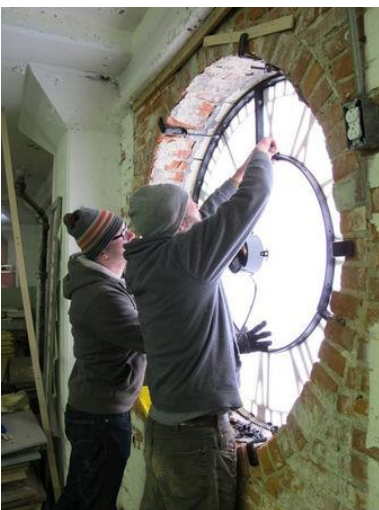
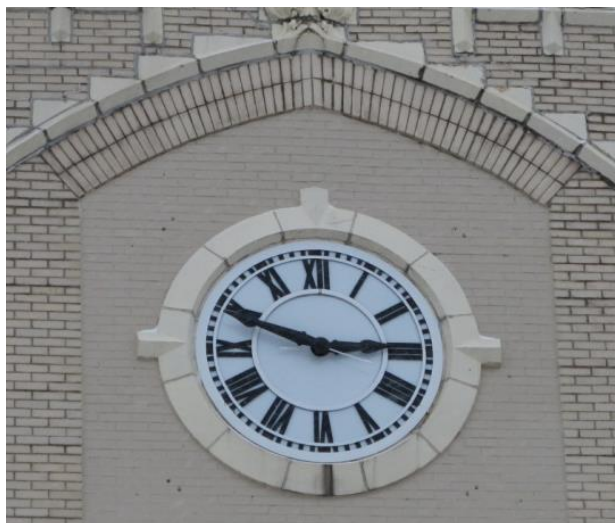
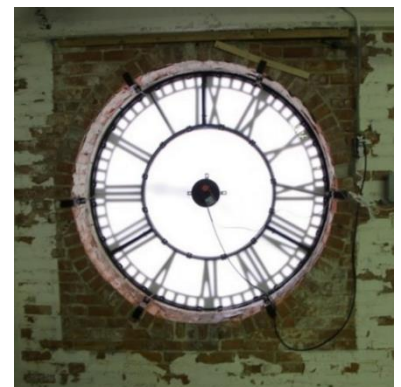
The courthouse clock hasn't kept good time for years, as many of the parts have worn out and couldn't be replaced. One of the hands had fallen off.

The Seth Thomas clocks were installed as part of a renovation after a 1907 fire. The works were replaced in the early 1950s. Macartney said that clock was commonly used in churches and municipal buildings at the time, and they've worked on that model before.

The Roman numerals and hands were made of wood. The hands were replaced with ones made of heavy-duty aluminum that had been powder-coated.

The work was completed in three days by Macartney's husband, Ian, the president and founder of the company, along with his shop technician Dan Mudde. They were assisted by Jeremy Berry, a Green Bay man hired to work outside the tower because of his experience with rigging. He went through the removable centers of each dial to clean the exterior and provided other assistance.

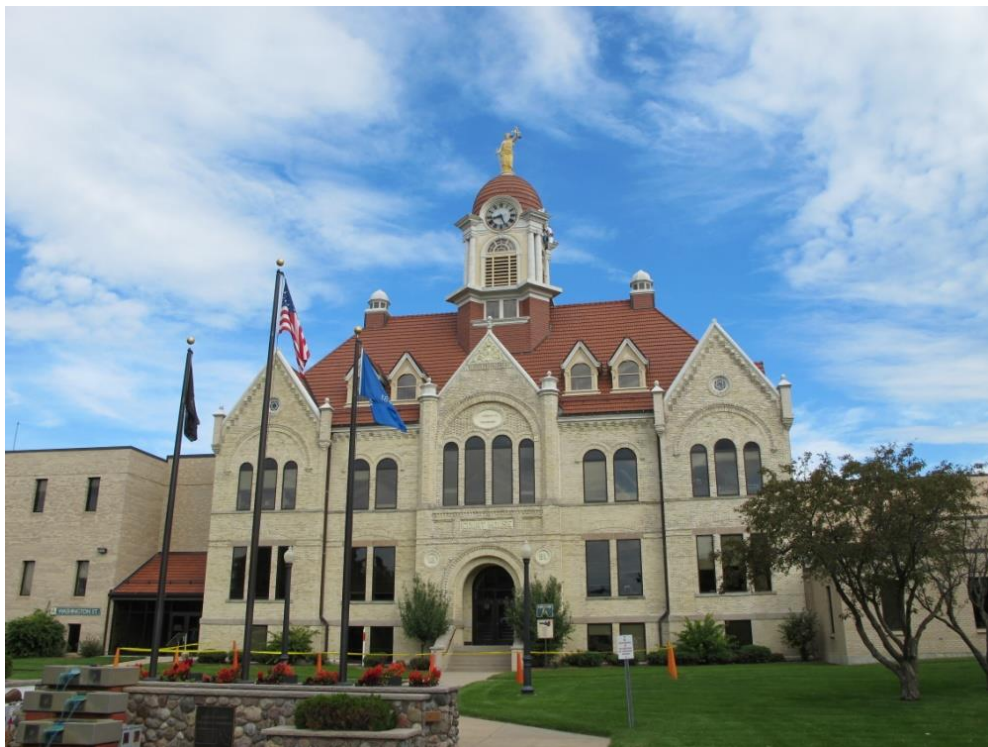
The clock restoration included replacement of the glass panes with translucent white polycarbonate. The verdigris patina on the bronze dial was left intact. New hands match the original, and an impulse-drive clock movement with a GPS-controlled master clock will keep the clock ticking in synchronization with Atomic time. New LED illumination was included in this restoration, which will turn on at dusk and off at dawn, automatically, every day throughout the year.

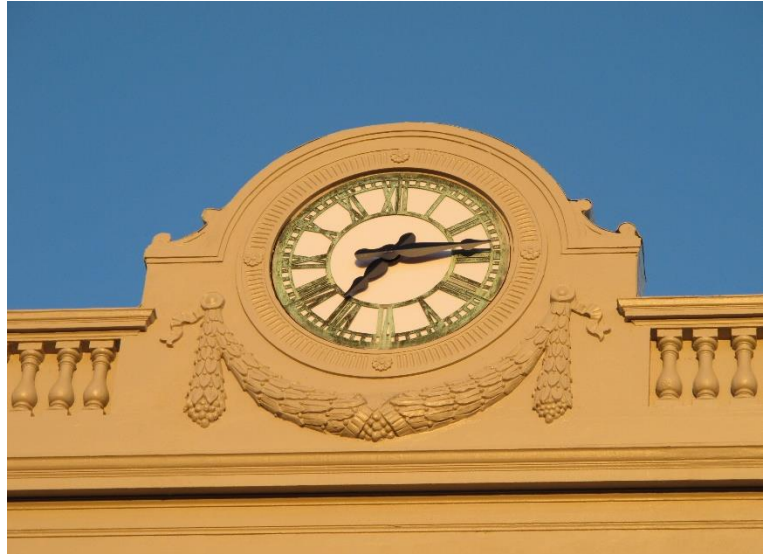
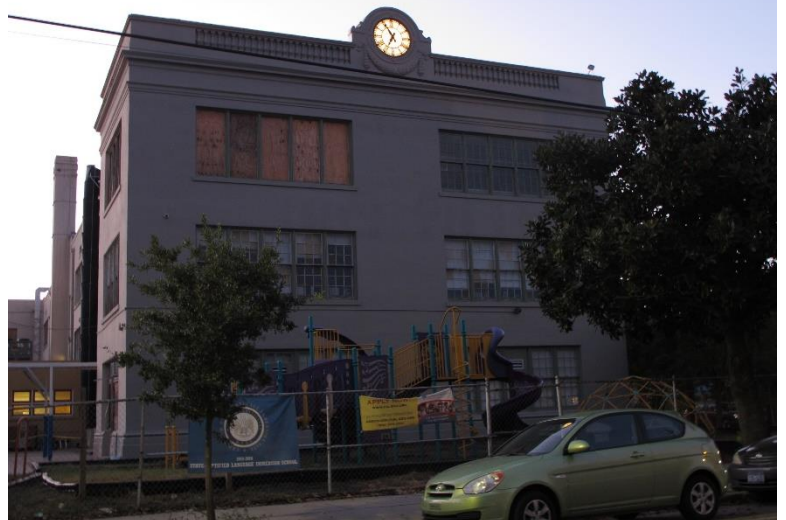
Andrew Jackson School, New Orleans, Louisiana

Another antique clock renovation LUMICHRON completed a few months ago is this cast bronze 5-foot diameter clock with original stonework surround. It sits atop the historic Andrew Jackson school, now home to the International School of Louisiana. It is located in the Lower Garden District of New Orleans, Louisiana, near Coliseum Square and a short walk from the Magazine Street arts neighborhood.
