LUMICHRON Clock Restoration

Clock Restoration Examples – References

LONGWOOD UNIVERSITY, Lancaster Hall, Farmville, Virginia

New clockworks, restored original cast-iron dial

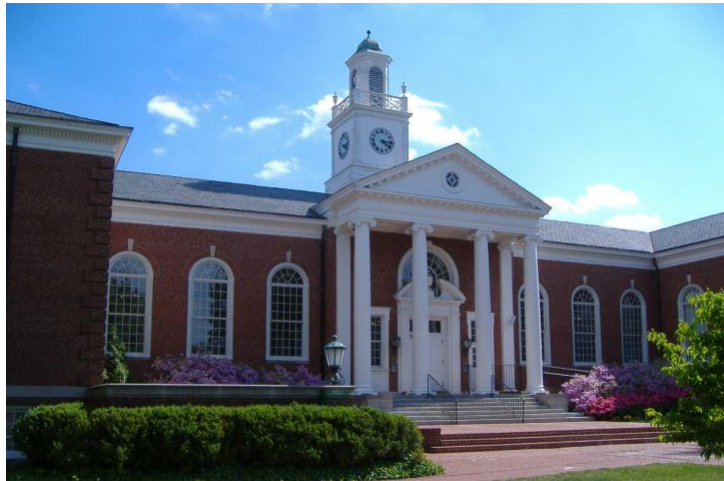
LUMICHRON was awarded the contract for the replacement/refurbishment of the four 54" diameter historic clocks at Longwood University in Virginia. This is a viable option when original mechanical clockworks need to be replaced, and the display clock is in good condition. In this case, the Seth Thomas 5-foot diameter Roman clock dials, made of cast iron with glass panes, just needed re-finishing, with new glass to replace broken or cracked panes.

Work began with a site visit. Then LUMICHRON staff removed the original cast-iron, glass-paned clock dials and brought them back to our shop in Michigan for sand-blasting, re-finishing, and cutting all new ¼" thick tempered glass panes, with a white translucent finish. We also fabricated new clock hands, and replaced the mechanical clockworks with "up-to-the-minute" slave clock movements and an automatic master clock controller with GPS synchronization for exact time keeping and bell striking functions

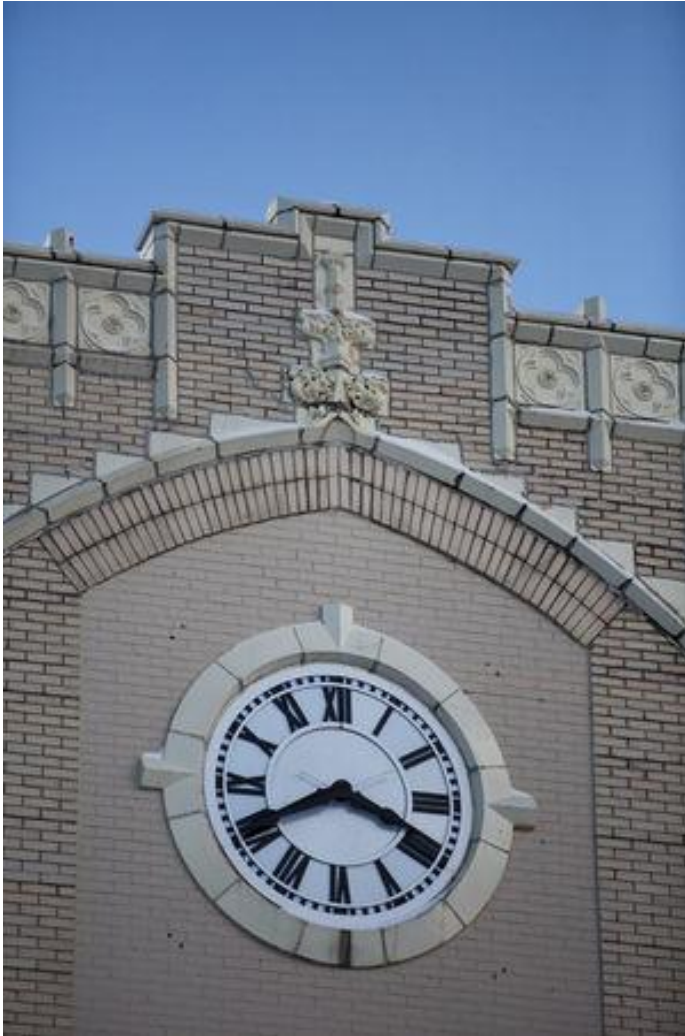
Restored Seth Thomas clock returns to Eastown's landmark Kingsley Building

The antique Seth Thomas clock hands atop the landmark Kingsley Building are turning again, greeting drivers approaching Eastown on Lake Drive SE as they once did.

Originally built in 1926, the clock was restored this summer by Grand Rapids clockmaker Ian Macartney's company **Lumichron**, and was installed last week on the top floor of the five-story building.

For years, the clock face and frame were frozen in stasis behind a square, modern clock with a Kent Records Management logo on the front of the building.

The clock's original inner-workings, brass gears, pendulum and wooden arms were **donated** to Bazzani in 2011 by Alan Teelander of Lowell, who saved them in his garage after Zondervan Publishing Co. moved from the building in 1974. The restored clock reuses the original cast-iron frame, but the original machinery could not be re-integrated into the clock, said Hawkins.

Instead, the clock has been automated with modern controls that are tied to a master clock in the building that "does everything but make hot chocolate." Back-lighting and seasonal time changes are all handled automatically. The clock face is backlit from dusk to dawn each day.

The restoration by Macartney took four months. Hawkins said the white translucent glass on the clock face was extremely difficult to locate in large and thick enough quantity, but Macartney found an art glass foundry in Pennsylvania which had some residual stock.

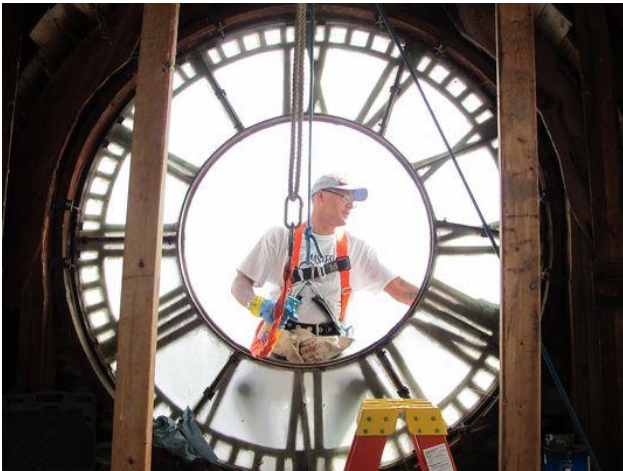
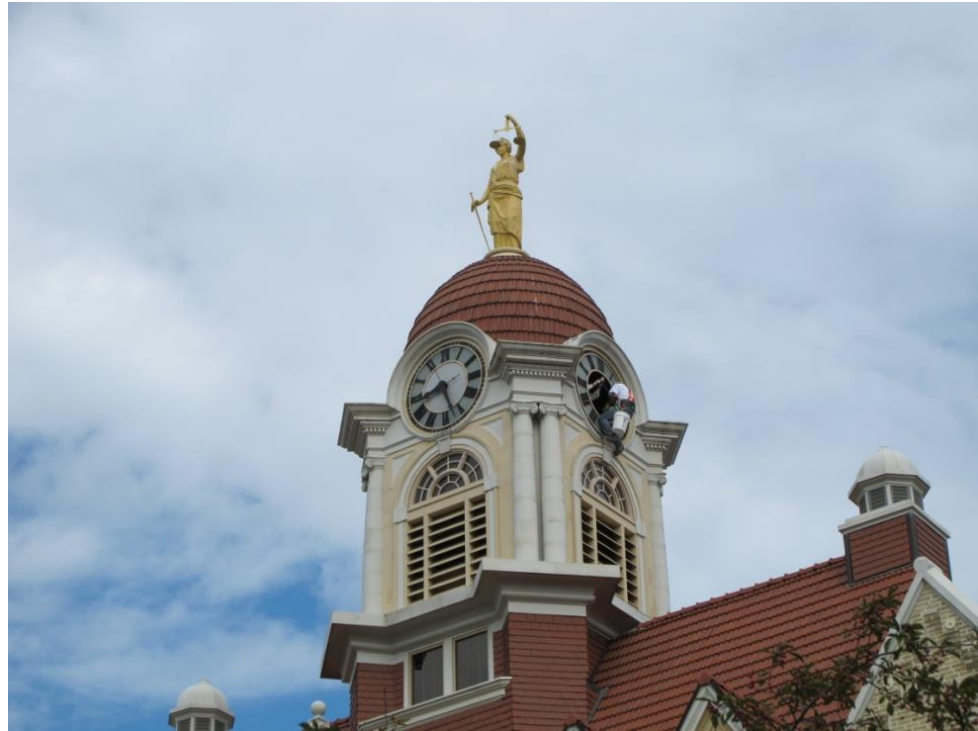
Oconto County, Wisconsin

People visiting the Oconto County Courthouse can again trust the century-old tower clock, thanks to a recently completed restoration project.

Installation of a new movement put all four faces of the 7-foot diameter clock in sync, said Karen Macartney, vice president of Lumichron, the Grand Rapids, Mich., company that did the work.

The courthouse clock hasn't kept good time for years, as many of the parts have worn out and couldn't be replaced. One of the hands had fallen off.

The state-of-the-art European movement is controlled by a computer that follows the government's atomic clock, and can adjust the time after power outages or switching to daylight savings time.

The Roman numerals and hands were made of wood. The hands were replaced with ones made of heavy-duty aluminum that had been powder-coated.

As part of the project, Lumichron also installed an LED light system to improve the illumination of the dials at night, replacing mercury vapor lights that cast a yellow sheen.

Lumichron also installed a new striker system for the cast bronze bell.

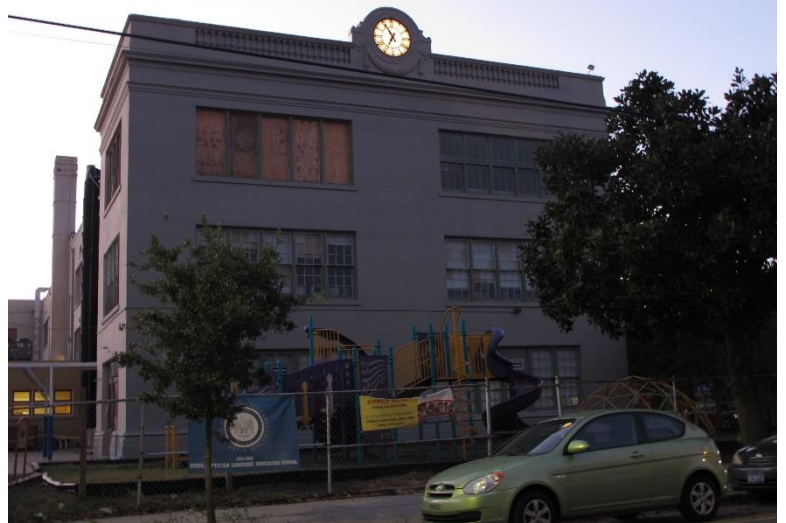
Andrew Jackson School, New Orleans, Louisiana

Another antique clock renovation LUMICHRON completed a few months ago is this cast bronze 5-foot diameter clock with original stonework surround. It sits atop the historic Andrew Jackson school, now home to the International School of Louisiana. It is located in the Lower Garden District of New Orleans, Louisiana, near Coliseum Square and a short walk from the Magazine Street arts neighborhood.

The clock restoration included replacement of the glass panes with translucent white polycarbonate. The verdigris patina on the bronze dial was left intact. New hands match the original, and an impulse-drive clock movement with a GPS-controlled master clock will keep the clock ticking in synchronization with Atomic time. New LED illumination was included in this restoration, which will turn on at dusk and off at dawn, automatically, every day throughout the year.
